Re: Raton Water Treatment Plant; Minor Industrial; SIC 4941; NPDES Compliance Evaluation Inspection; NPDES #NM0029891; August 20, 2019

NPDES Compliance Inspection Report

Compliance Evaluation Inspection Raton Water Treatment Plant NPDES Permit NM0029891 Inspection Date: August 20, 2019 Further Explanations

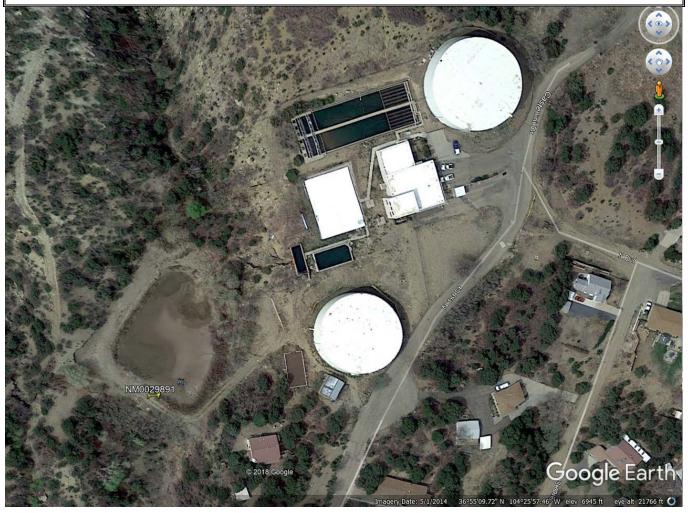
NMED/SWQB Official Photograph Log Photo # 1							
Photographer: Google Earth	Date: 5/1/14	Time: unknown					
City/County: Colfax County		State: New Mexico					
Location: Raton Water Treatment Plant							
Subject: aerial view of WTP
